**Sluffers Inclosure, New Forest  
Inclosure bank & ditch removal for HLS stream restoration**

**Archaeological Watching Brief Statement**

Prepared by the New Forest National Park Authority on behalf of the Verderers of  
the New Forest Higher Level Stewardship Scheme

September 2025

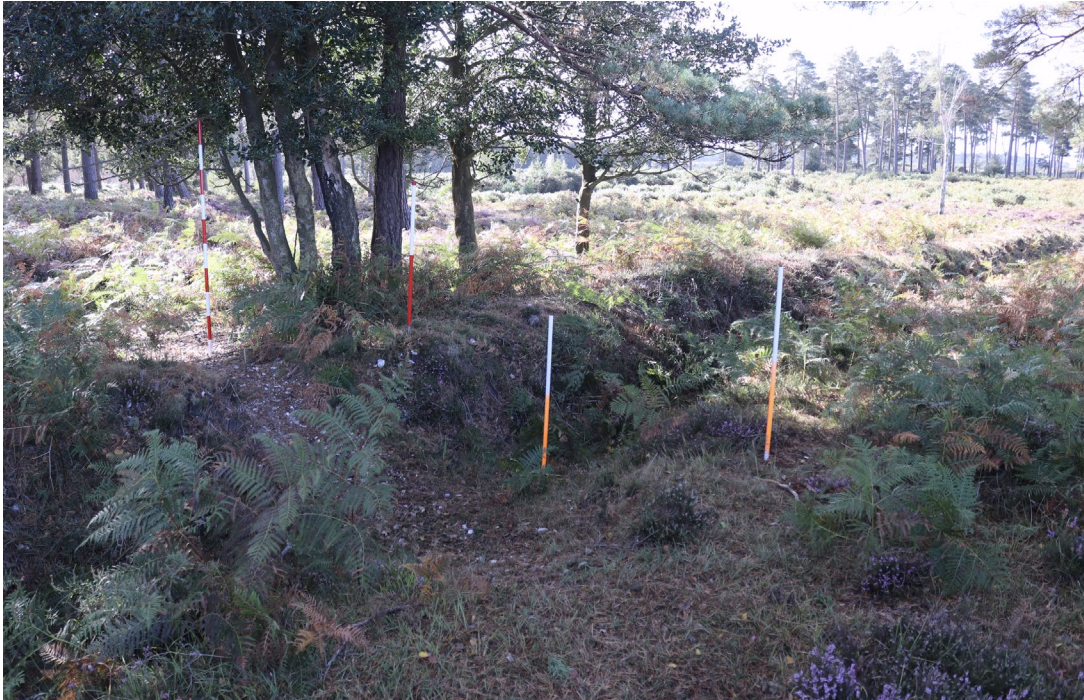
Photo 1: North end of eastern Inclosure earthwork boundary, looking SE.

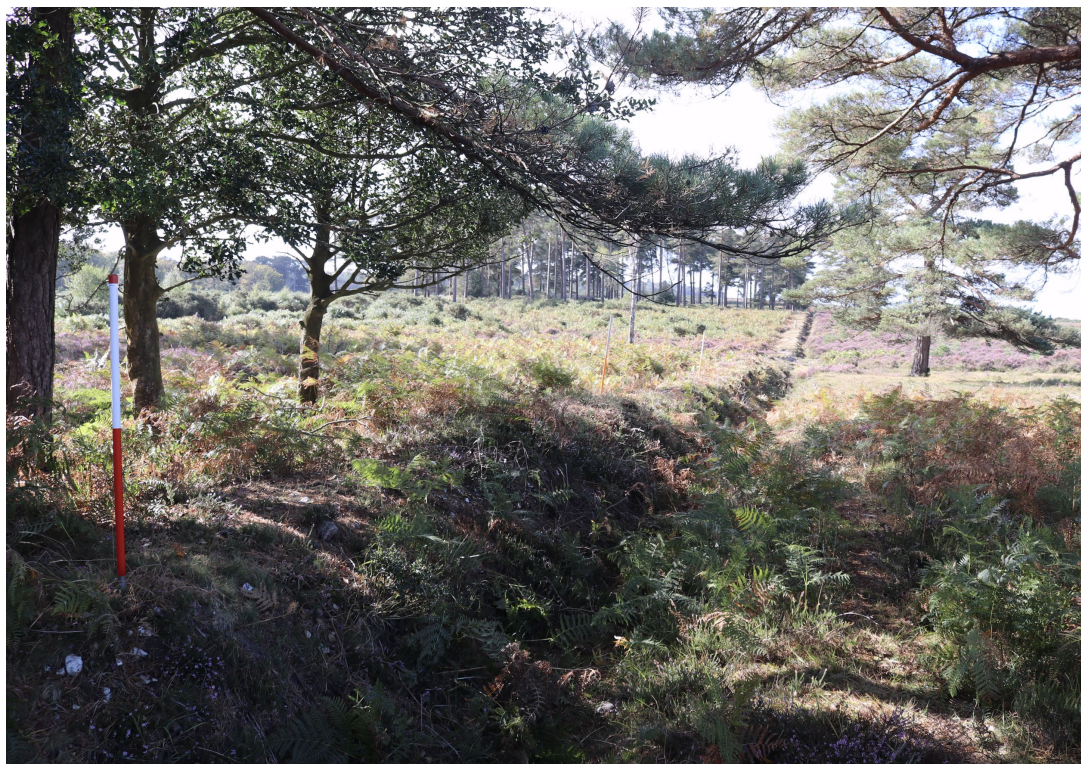
Photo 2: View along northern end of eastern boundary earthwork. Looking S.

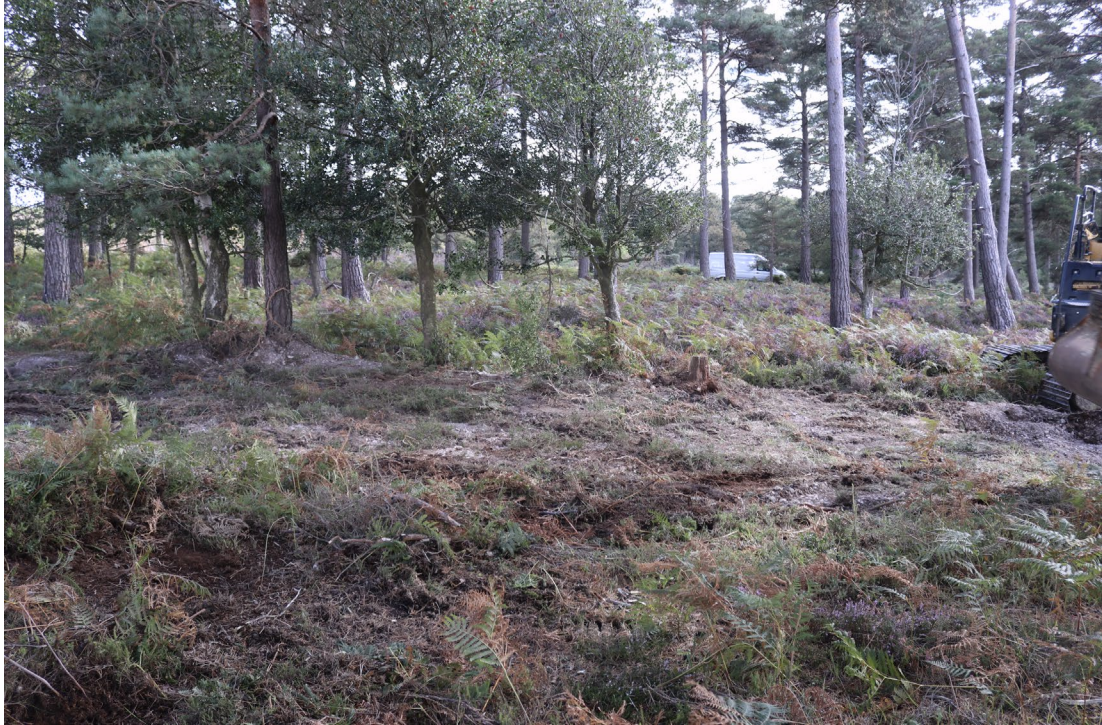
Photo 3: Northern end of eastern boundary earthwork, post levelling. Looking E.

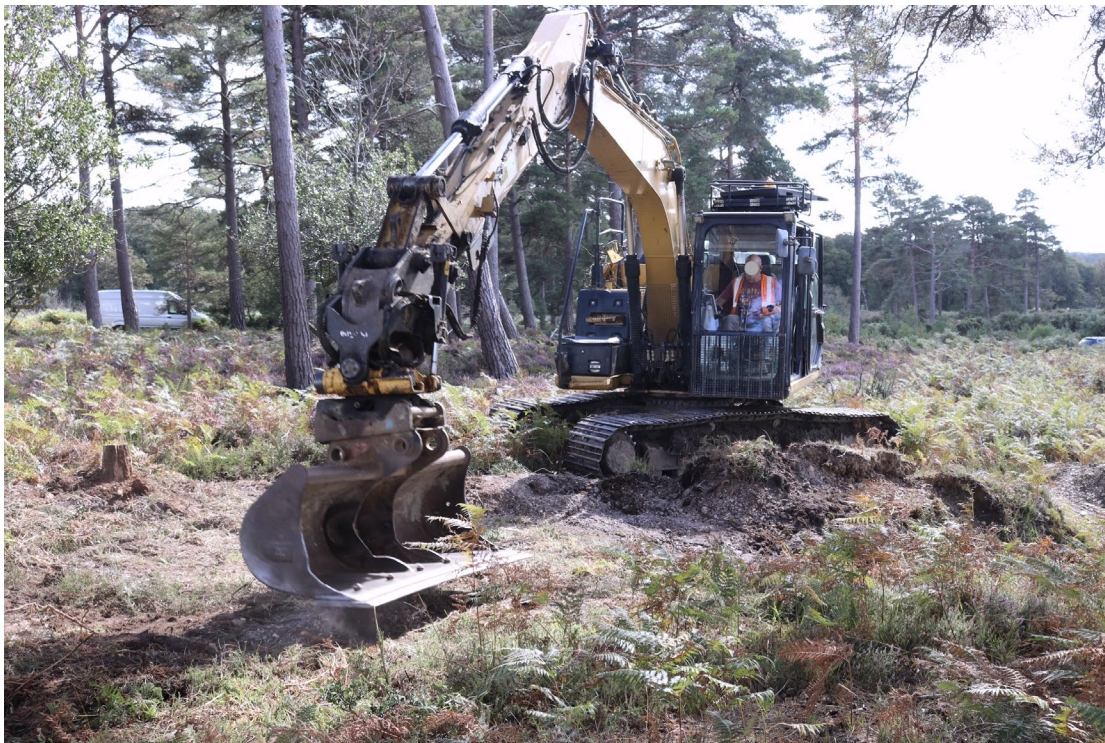
Photo 4: Working shot. Northern end of eastern boundary earthwork.

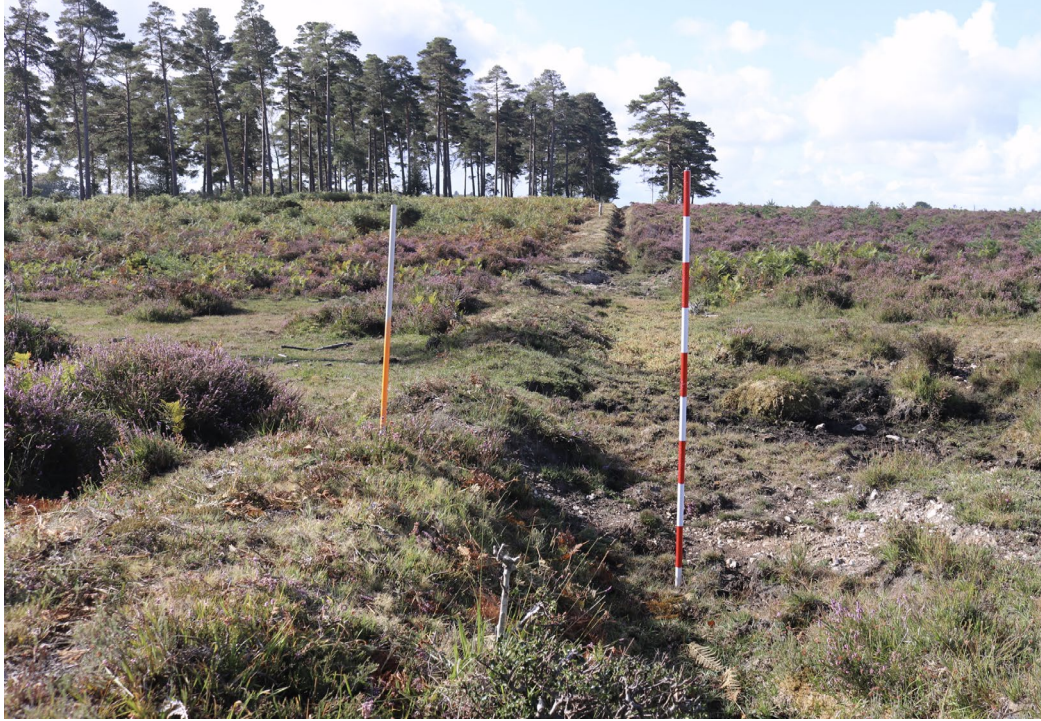
Photo 5: Northern end of eastern boundary earthwork, looking SW.

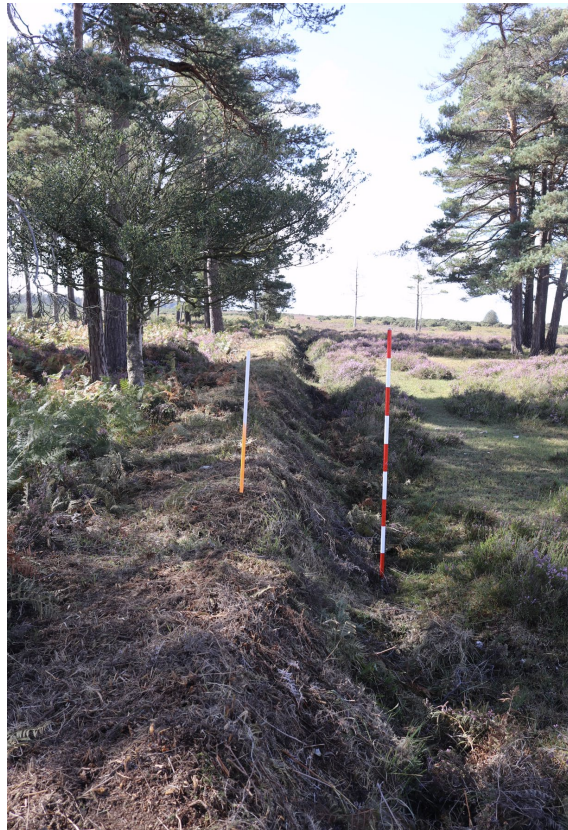
Photo 6: Continuation SW of eastern boundary earthwork, looking SW.

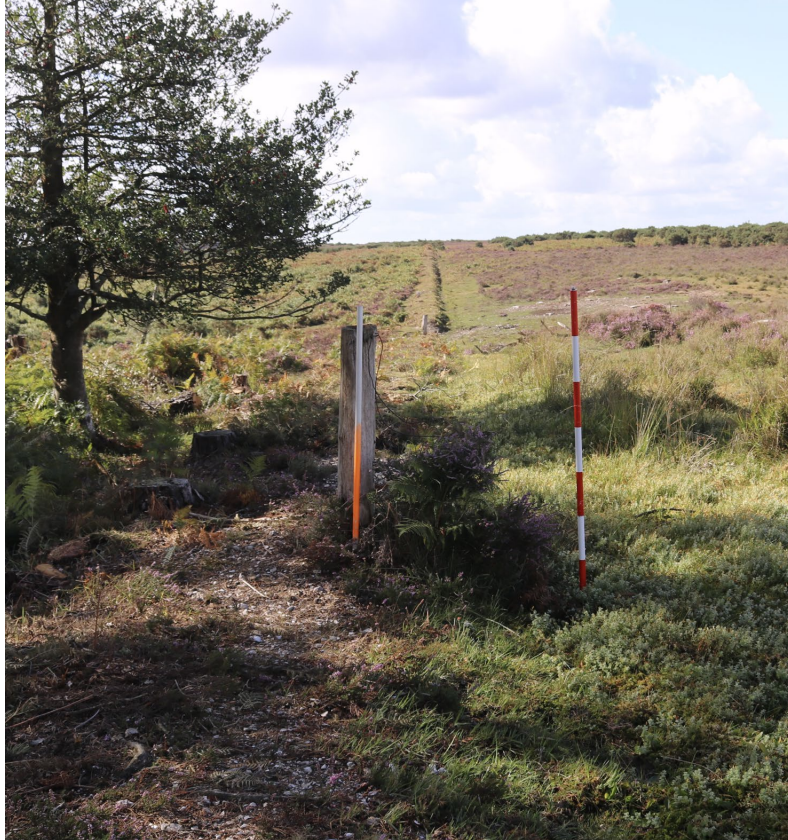
Photo 7: Continuation SW of eastern boundary earthwork, looking SW.

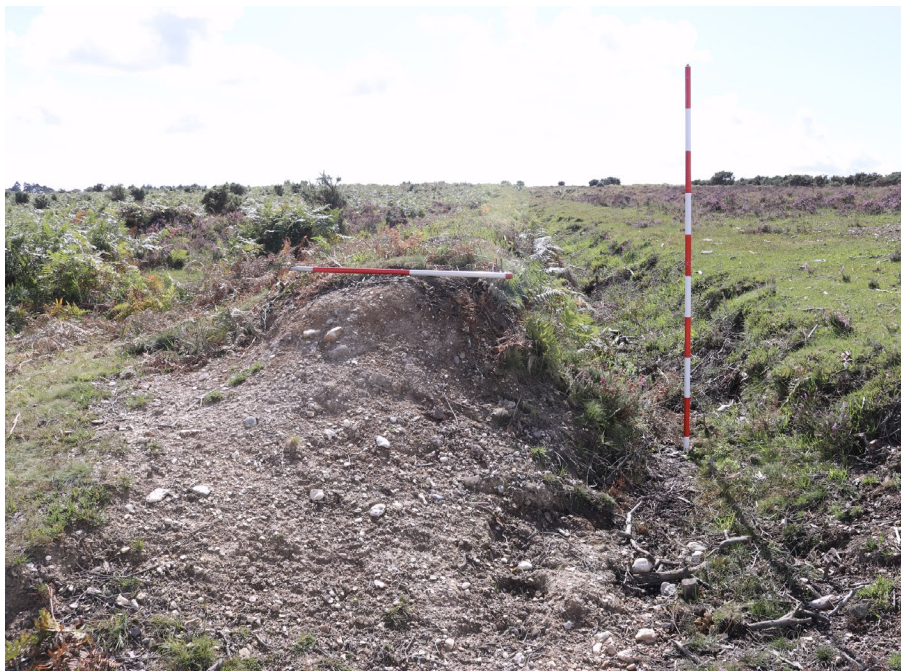
Photo 8: Continuation SW of eastern boundary earthwork, looking SW.

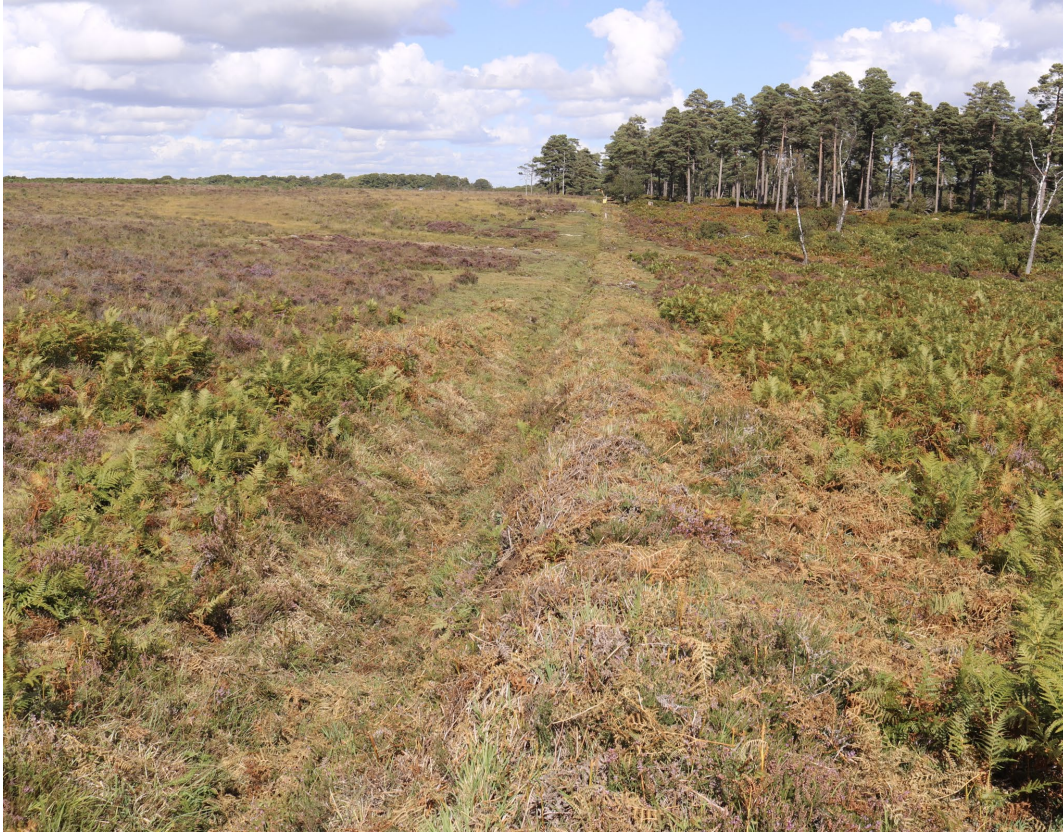
Photo 9: Southern end of eastern boundary earthwork, looking NE.

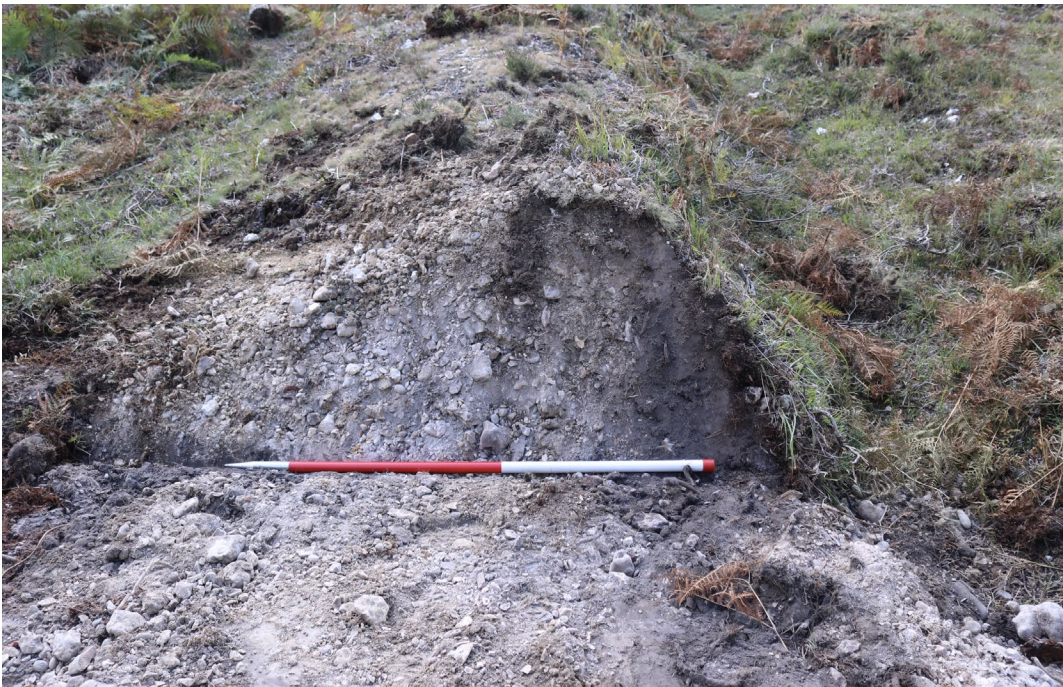
Continuous monitoring and examination of two cross sections through the eastern boundary confirmed that the ditch and bank were contemporaneous with the ditch fill forming the bank, (Photos 10 and 11).

Photo 10: Cross Section (Section A) through eastern boundary bank, looking SSW. (1m scale). The same bank material was noted in the ditch as work progressed.

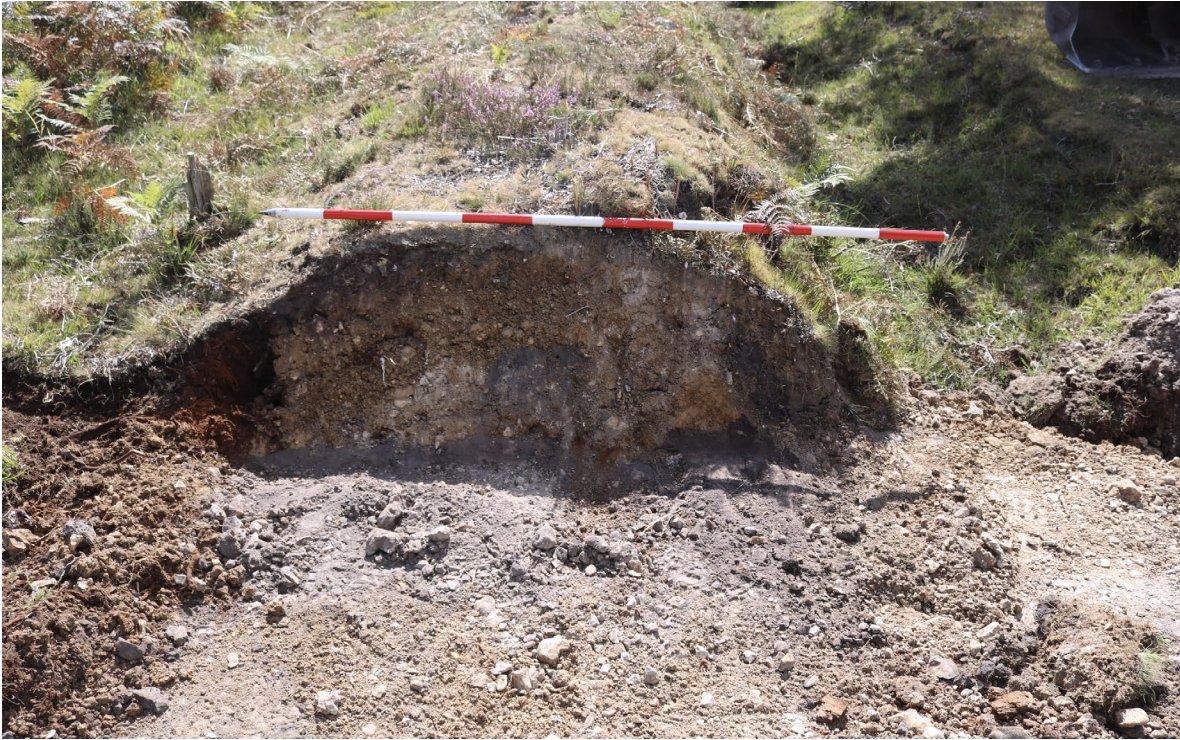
Photo 11: Cross Section (Section B) through eastern boundary bank, looking SSW. (1m scale). The same bank material was noted in the ditch as work progressed.

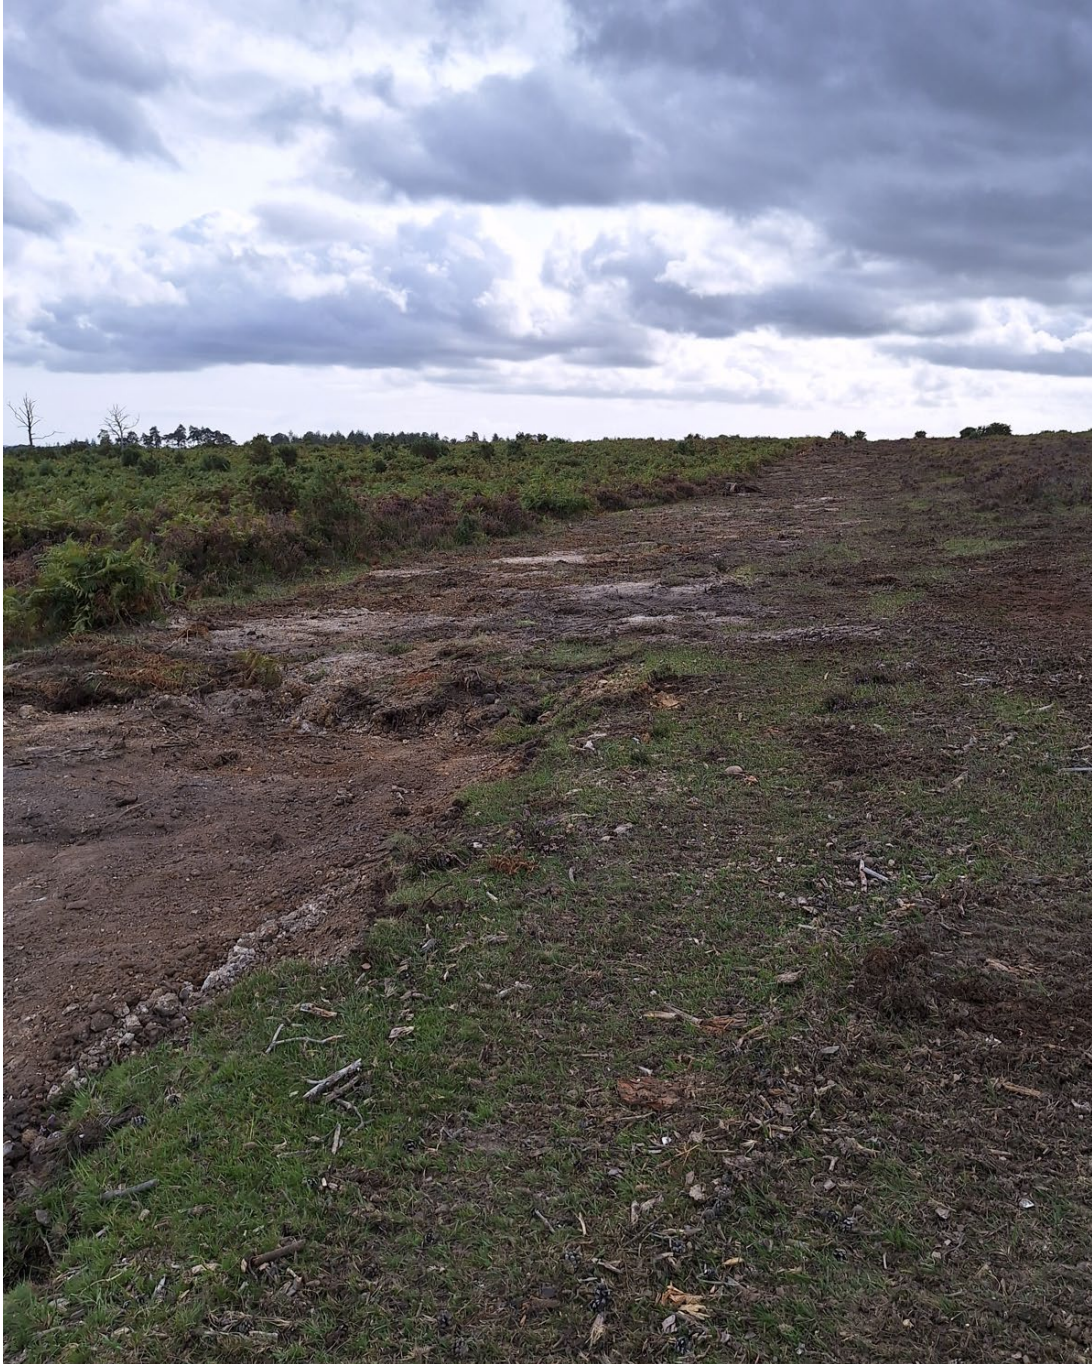
Photo 12: Southern end of eastern boundary earthwork, post levelling, looking S.

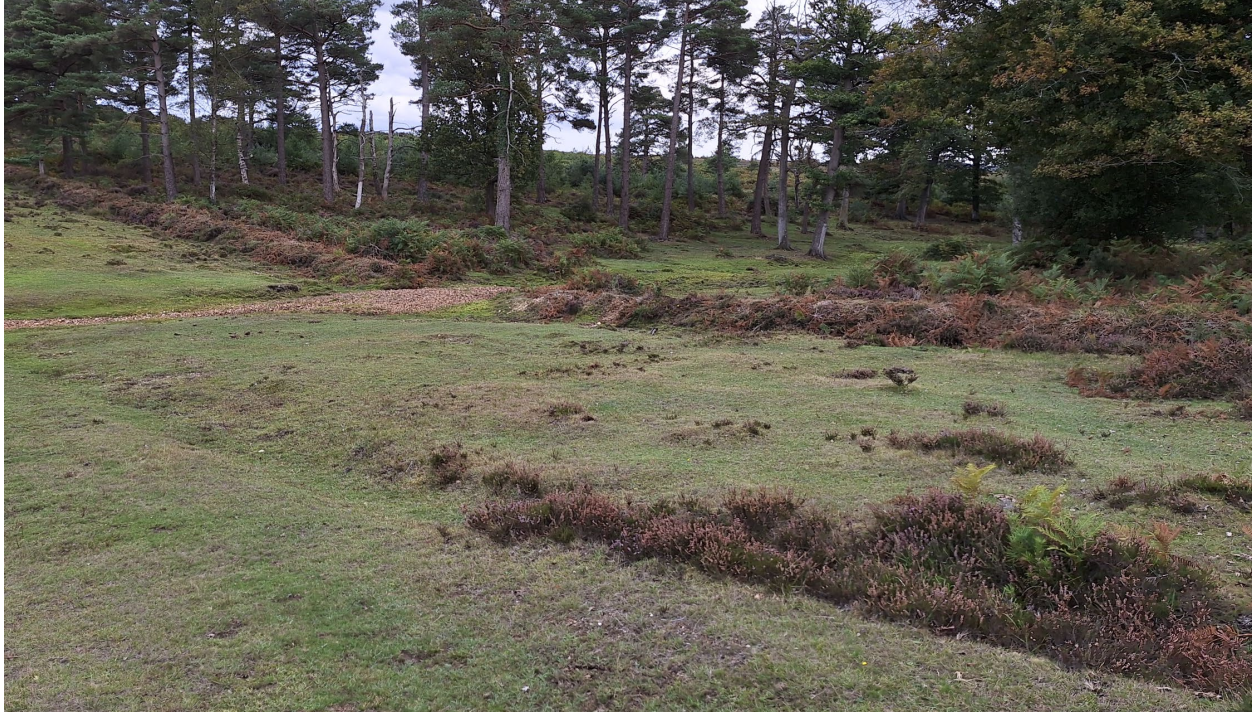
Photo 13: Northern boundary earthwork. Looking ESE.

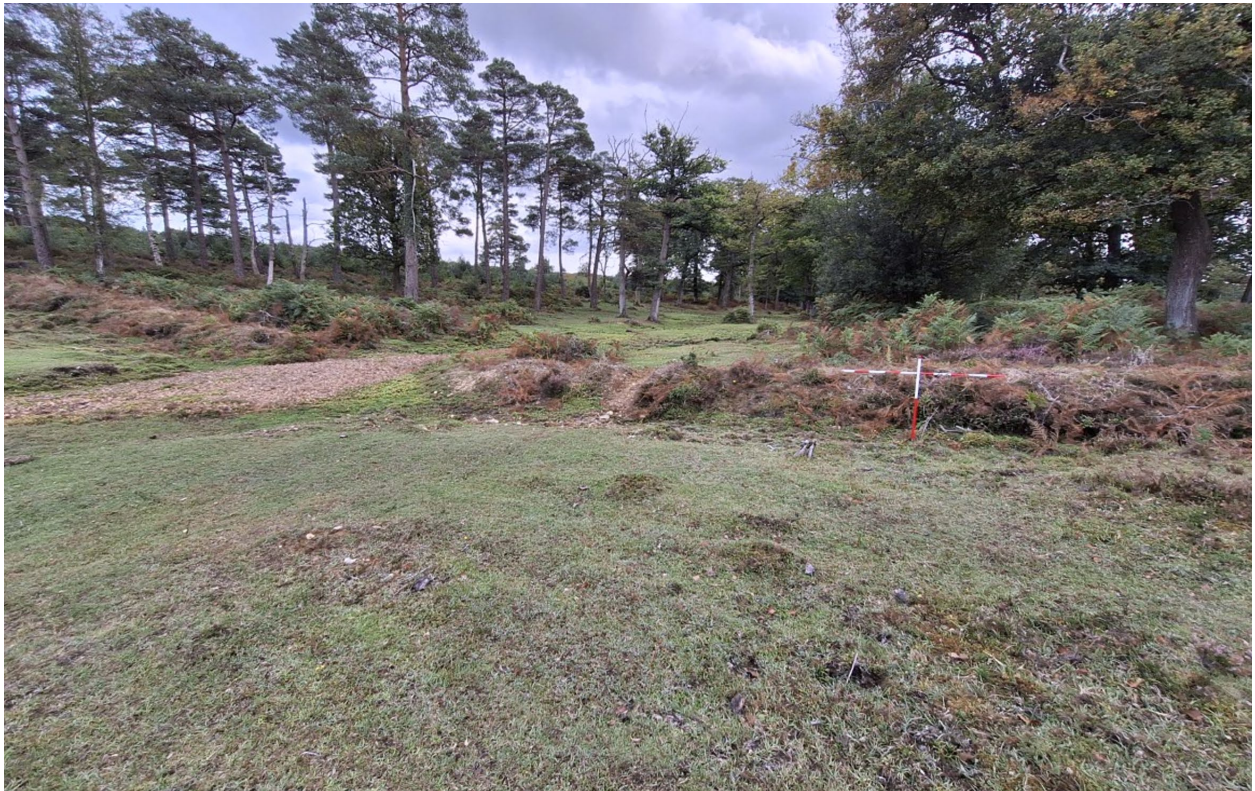
Photo 14: Northern boundary earthwork. Looking SE.

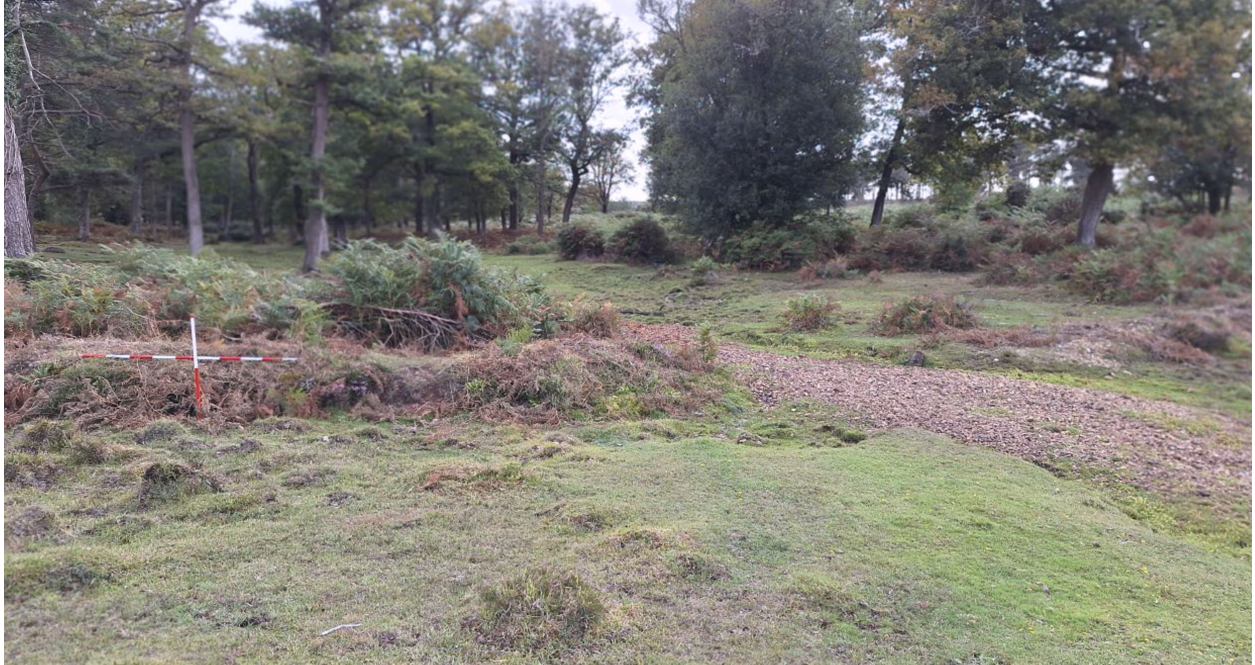
Photo 15: Northern boundary earthwork. Looking SW.
