# New Forest Wetland Restoration Vegetation Monitoring: Harvestslade and Slufters, 2022.

Higher Level Stewardship Agreement.

The Verderers of the New Forest AG00300016

Footprint Contract Reference: 702

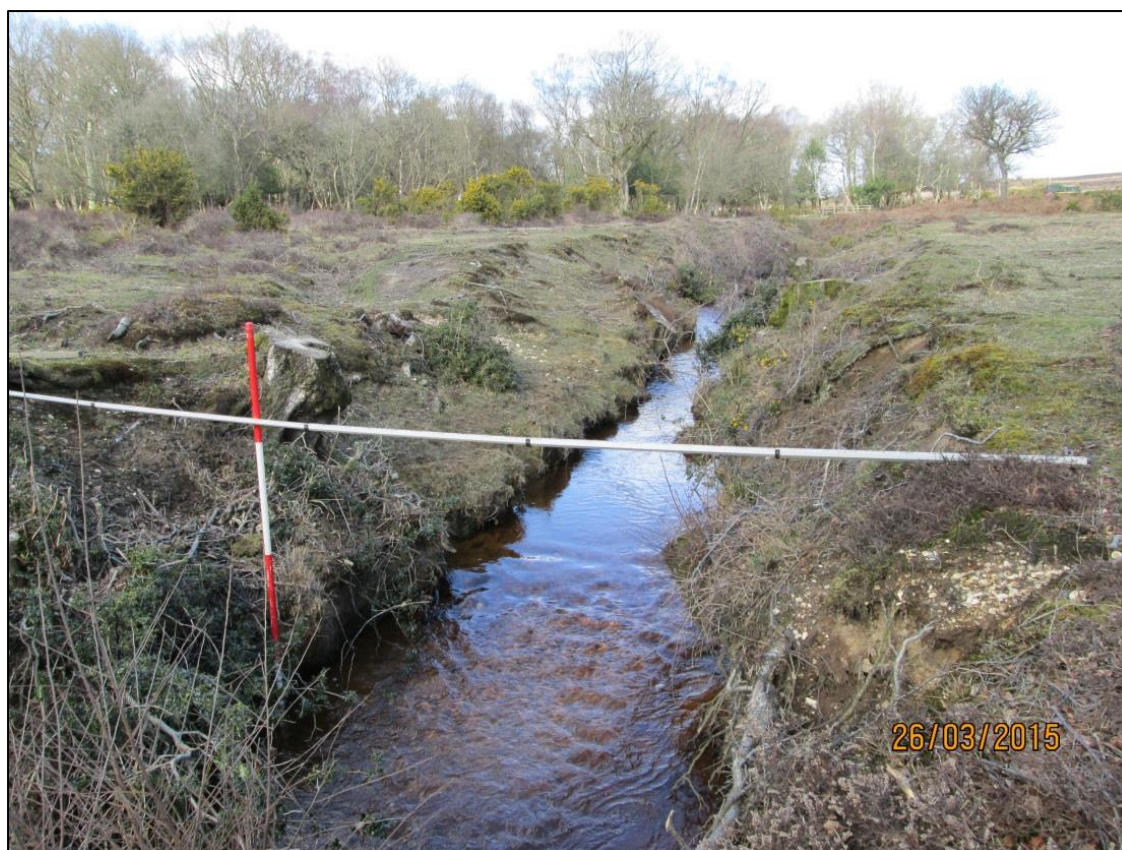
- 5.2 Prior to restoration, the watercourse at Harvestslade was deeply incised and straightened, and the interaction with the floodplain was inconsistent. Figure 4 provides a view of the watercourse just downstream of the bridge before restoration (facing upstream). The watercourse is straight, deep and with no in-channel or marginal vegetation. The bankside vegetation is dry and there is no transitional zone, such as a shallow, poached margin.

Figure 3: The channel pre-restoration at Harvestslade (image sourced from Forestry England).

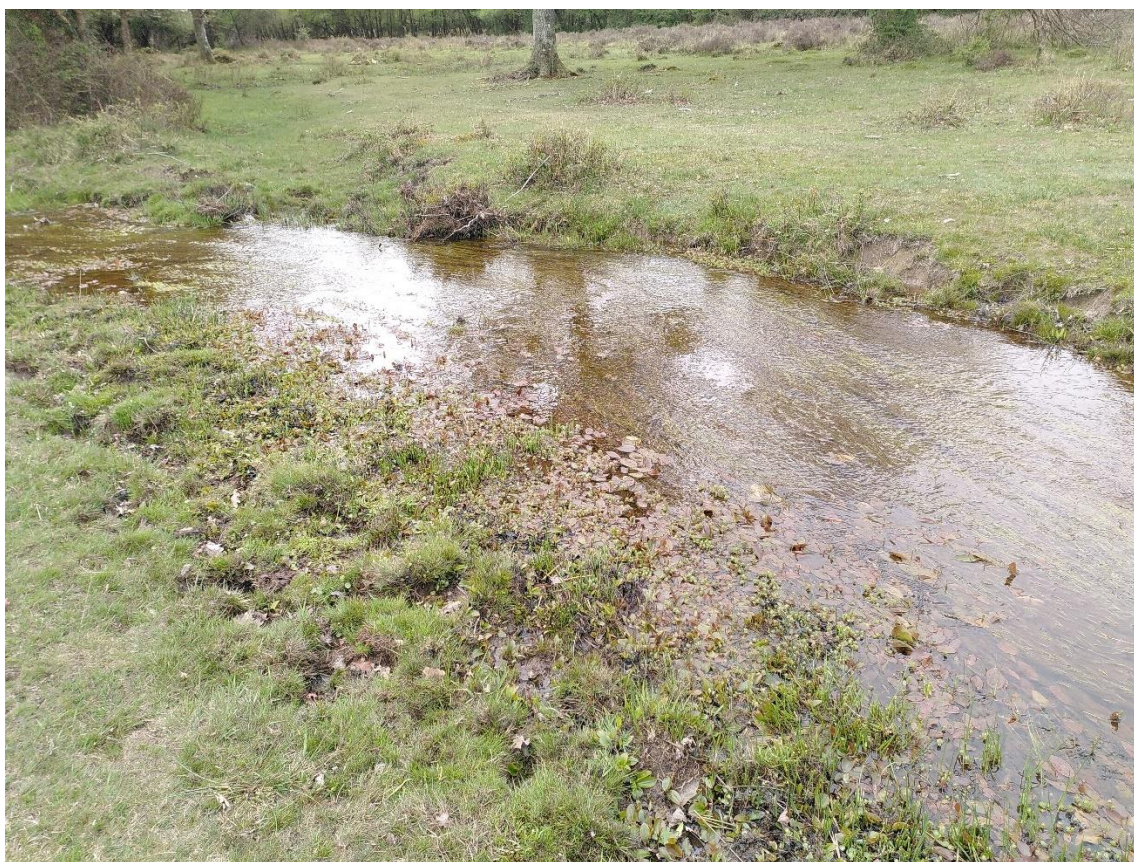
- 5.3 Following restoration, the character of the watercourse has changed substantially and there are also changes to the surrounding wetland habitats. Figure 4 provides a view of the new meandering channel in the

same area of the floodplain (facing downstream). The banks are shallow and support vegetation typical of Oligotrophic Stream, with Bog Pondweed and Marsh St. John's-wort and there is in-channel vegetation in the shallow watercourse. There is no incision or bankside spoil and it is clear that the water can spread out onto the adjacent Floodplain Lawn. The reinstated meander means that the extent of the in-channel, marginal and transitional vegetation has increased. There is light poaching along the bankside and Figure 5 shows a more extensive area of this Poached and Disturbed Habitat which supports a large population of Pillwort.

Figure 4: Restored Oligotrophic Stream with marginal and in-channel vegetation at Harvestslade.

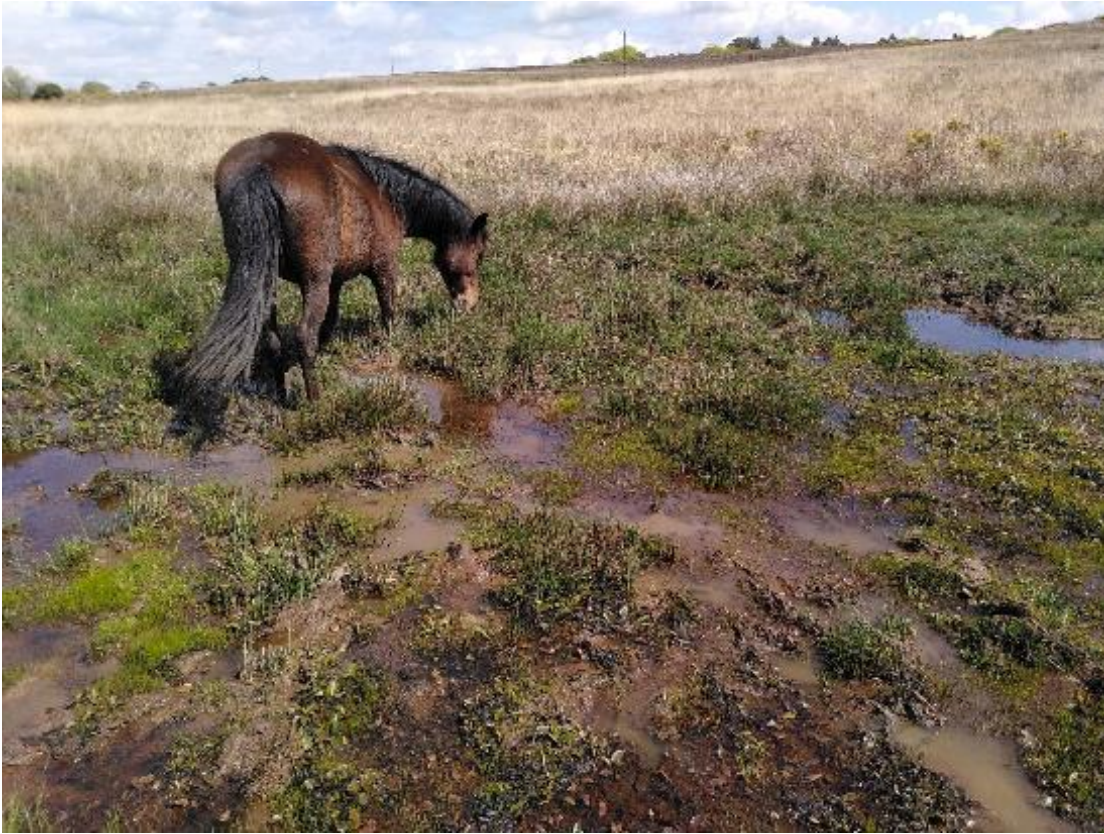
Figure 5: Poached and Disturbed Habitat supporting a significant population of Pillwort at Harvestslade

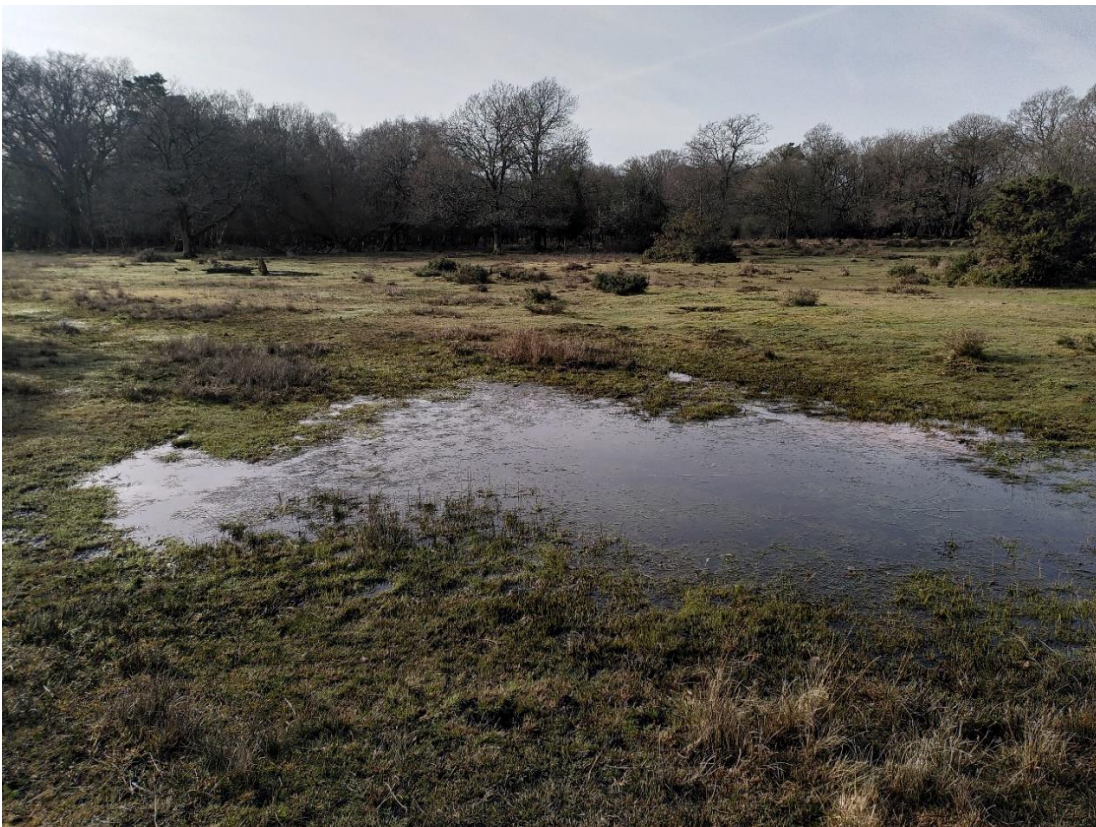
- 5.4 Figure 5 show the adjacent area of Floodplain Lawn in the winter of 2023. The floodplain has re-wetted and now supports Ephemeral Pools, another typical New Forest wetland habitat (there is no mention of this habitat at Harvestslade prior to the restoration).
- 5.5 There is no direct evidence in terms of the area and quality of habitat to show how the restoration is supporting the integrity of the associated Valley Mire. However, the slowed flow will reduce drainage and help maintain appropriate hydrological conditions.

Figure 6: Re-wetted floodplain at Harvestslade, winter 2023.

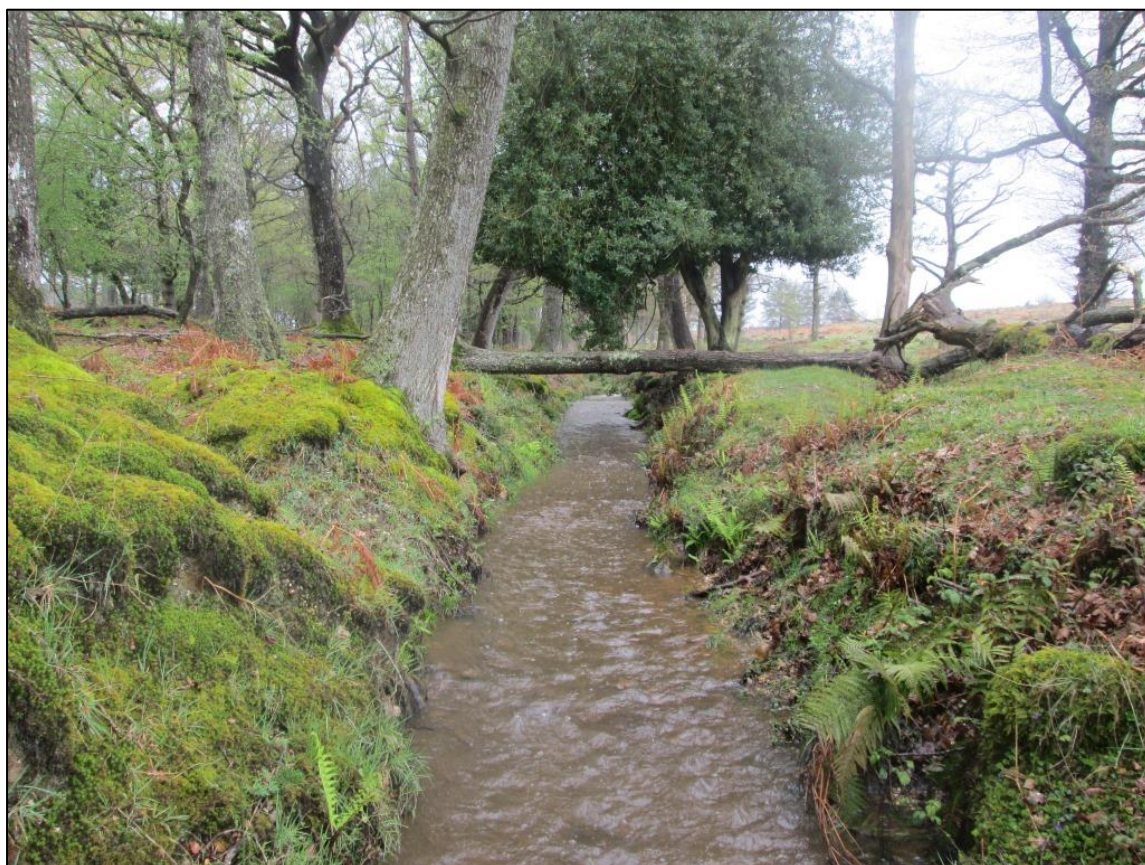
- 5.6 Before restoration, the watercourse running through Slufters was over-deepened and straightened, resulting in a disconnect with the floodplain and the loss of in-channel, marginal and floodplain features. As at Harvestslade, the incised banks meant that there was little marginal vegetation and no transition to Floodplain Lawn. Figure 7 shows a view of the channel before restoration, in which this is apparent.

Figure 7: The channel pre-restoration at Slufters (image sourced from Forestry England).

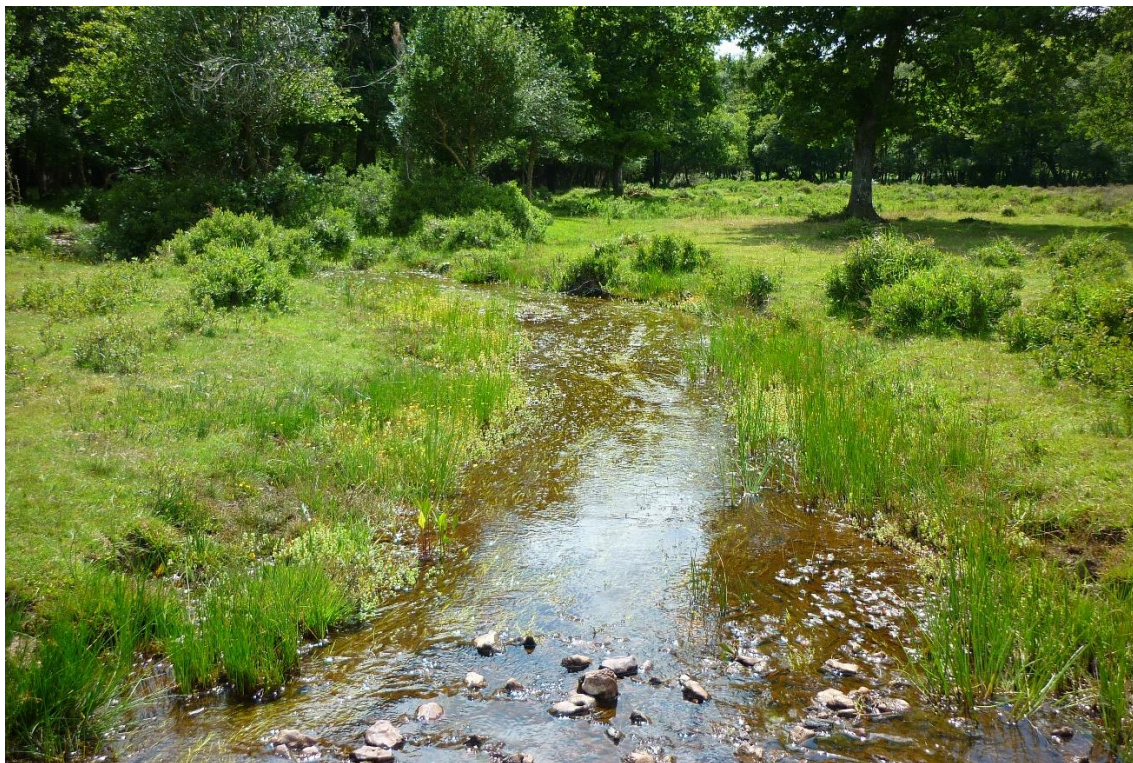
- 5.7 Following restoration, the channel is now more sinuous. The channel is no longer incised and the watercourse can connect with the floodplain. There is woody material in the stream and erosional and depositional features indicate that natural processes are functioning. Due to the more recent nature of the restoration interventions at Slufters, some of the habitats were transitional in nature at the time of the survey, but typical Oligotrophic Stream vegetation was frequent within the channel and the transition to adjacent Floodplain Lawn was intact (see Figure 8). Poached and Disturbed Habitat was frequent and in places supported Pillwort.

Figure 8: The channel in 2022, showing well developed marginal and in-channel vegetation and plenty of room for the water to spread laterally onto the floodplain.

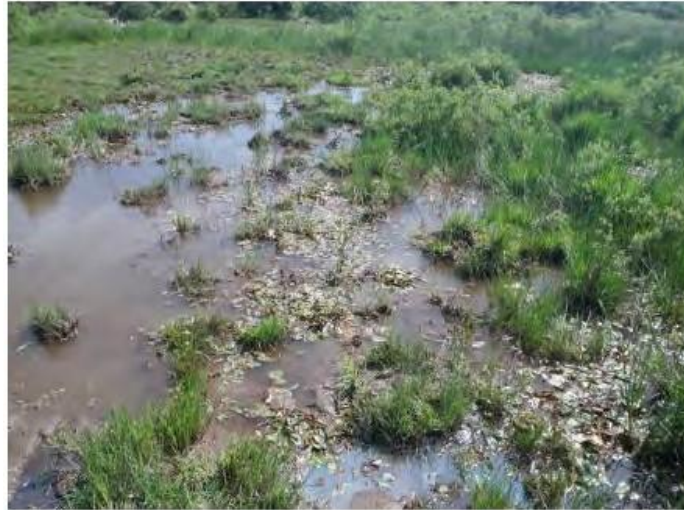
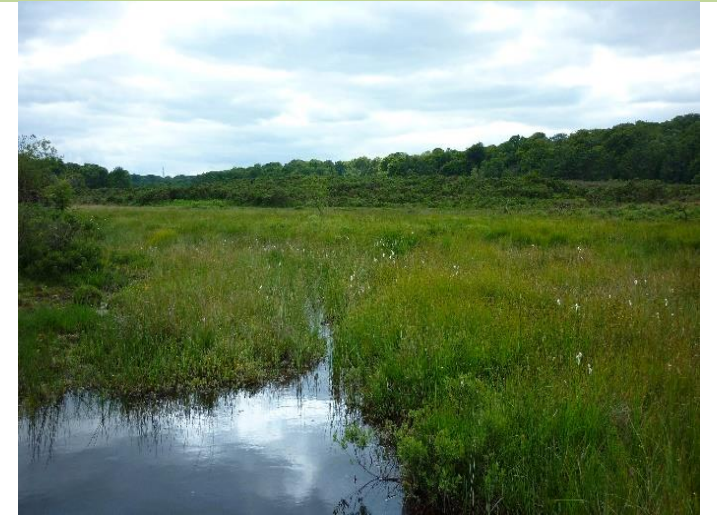
H46  
SU  
20966  
06117

Photo taken facing downstream from the bridge. Water flow has been slowed downstream creating a larger wetland area with Bottle Sedge, Sharp-flowered Rush and Cottongrass.

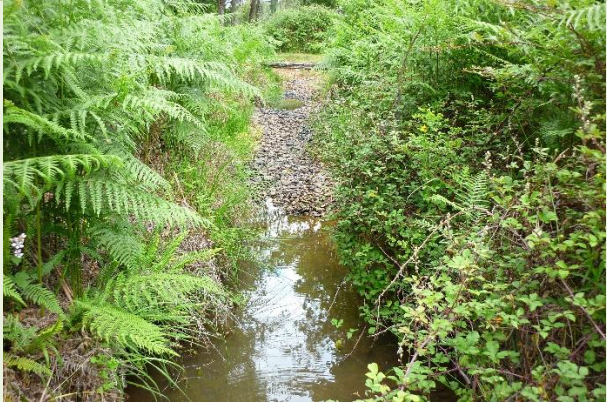
| <p>I<br/>SU<br/>23154<br/>09775</p> | <p>Main channel which is incised at this point and relatively deep with no in-channel vegetation and the steep sides are dominated by Bracken and Bramble. Shingle has been placed in the channel to modify the flow.</p> <p>Photo taken at the bottom of the catchment adjacent to a post-and-wire fence marking the bottom of the restoration works. The photo is facing north, which is upstream along the main channel.</p> | | |

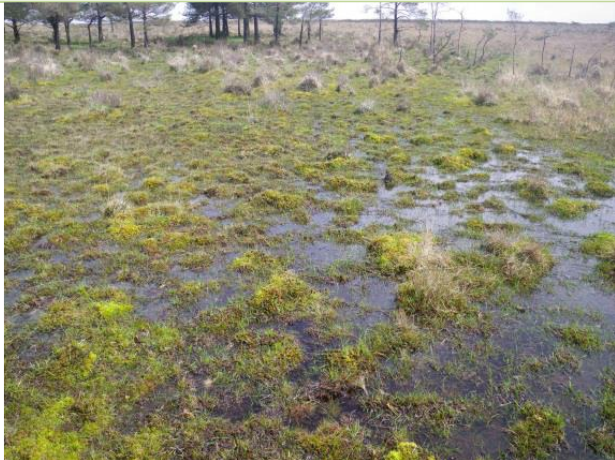
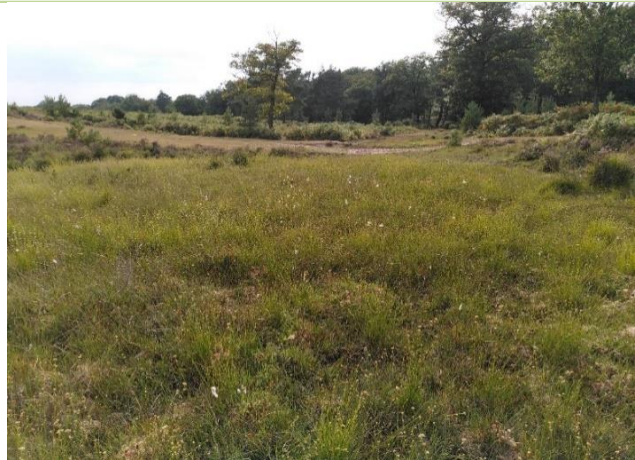
| <p>J<br/>SU23235<br/>11240</p> | <p>The lowest point of the Valley Bog showing M21a type vegetation. The 2014 photo is nearby at but shows much Soakway vegetation – it may be above the Valley Bog</p> <p>Taken facing E from the foot of the Bog</p> | | |
